Dunmore Lakes Sand Project

Annual Review

1 July 2018 – 30 June 2019

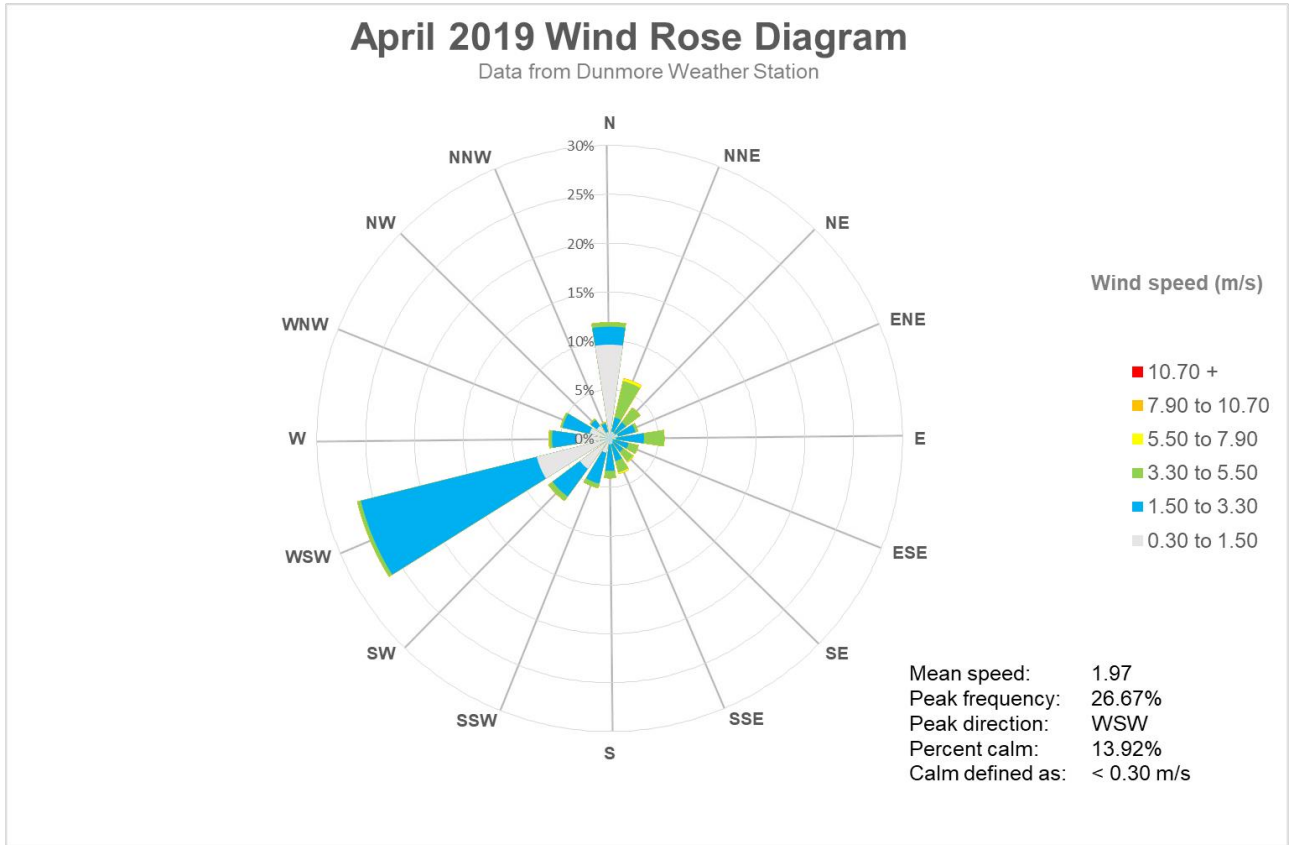
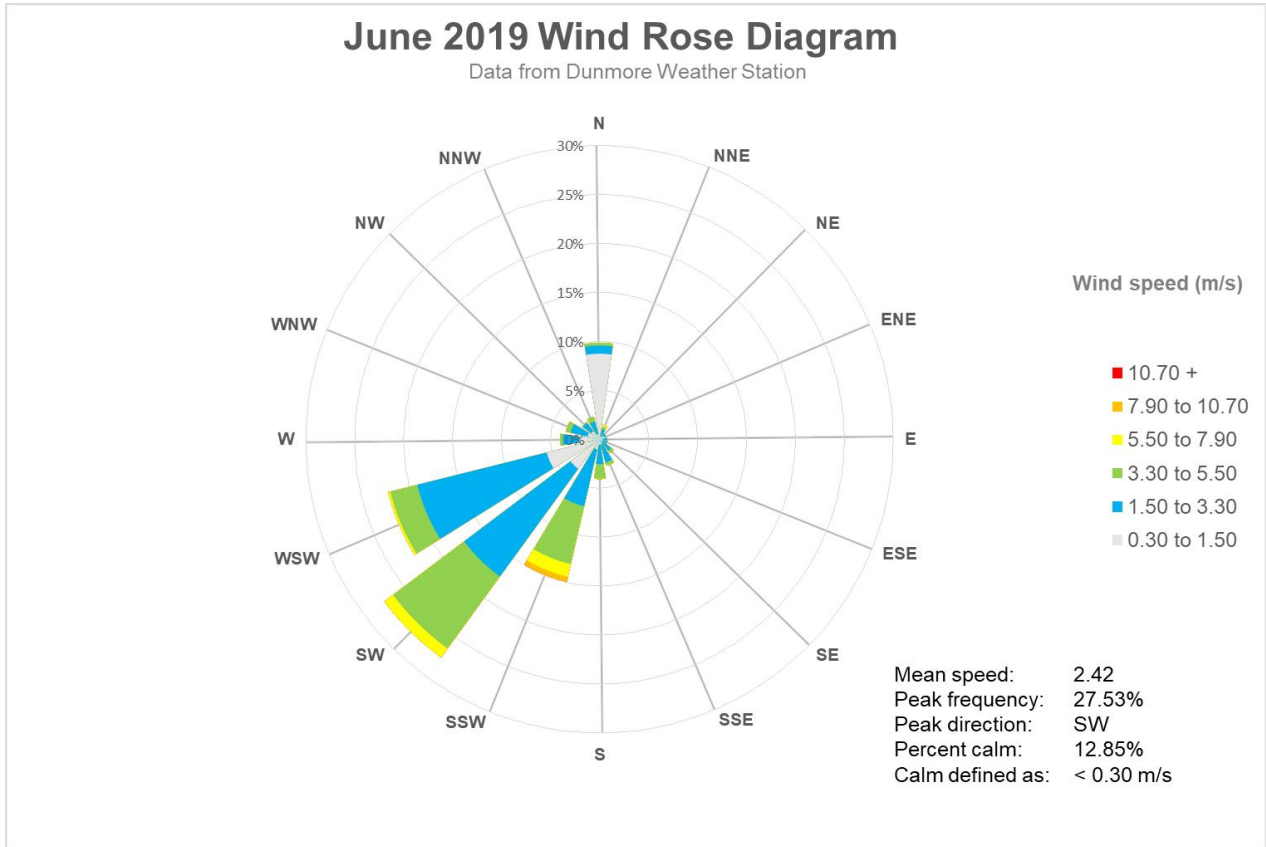
Prevailing winds were from the WSW during the majority of the year with the exception of the summer months. In summer the prevailing wind tended to be from the N or NNE. There was a lower percentage of calm conditions with no/low wind in winter. This is consistent with historical trends for the site and the region generally

The measured wind conditions experience on site for FY19 is shown below in Table 25. Monthly wind roses and seasonal wind roses are shown in Figure 8 to 20.

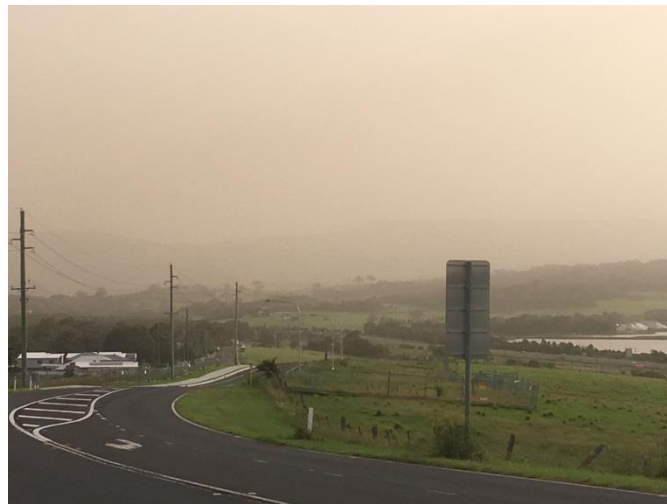
Figure 26 Dust Storms 12-14th of February

It is important to note that a state wide dust storm was experienced regionally from 12-14th of February which caused elevated readings for February at most sites. Despite this, annual averages were still below impact assessment criteria. Images of the dust storm is shown in Figure 26-27 in Appendix B.

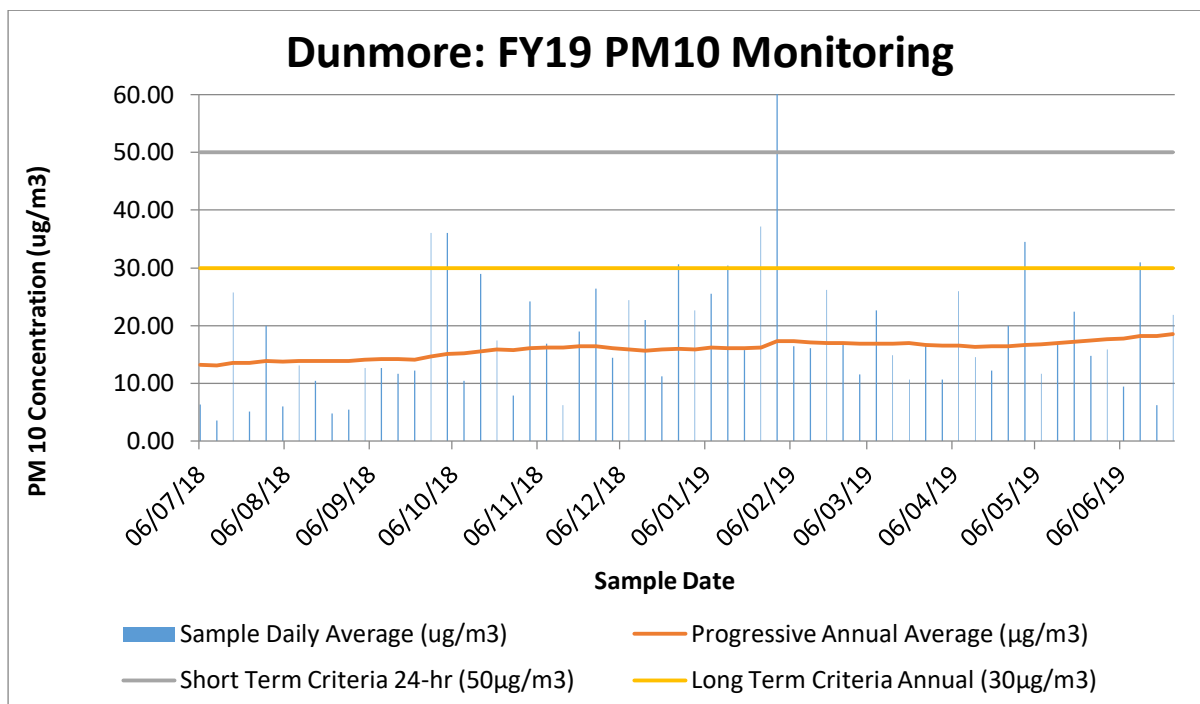
Figure 28 FY19 Dunmore PM10 Monitoring

There was one (1) reading above short term PM10 criteria. On 1/02/19 a reading recorded at the HVAS located at monitoring point 5 had a reading of 81.47ug/m3. An investigation was undertaken of the operations and ambient conditions experienced on 1 February. Findings were sent to DPIE and EPA within 7 days of receiving these results. To summarise:

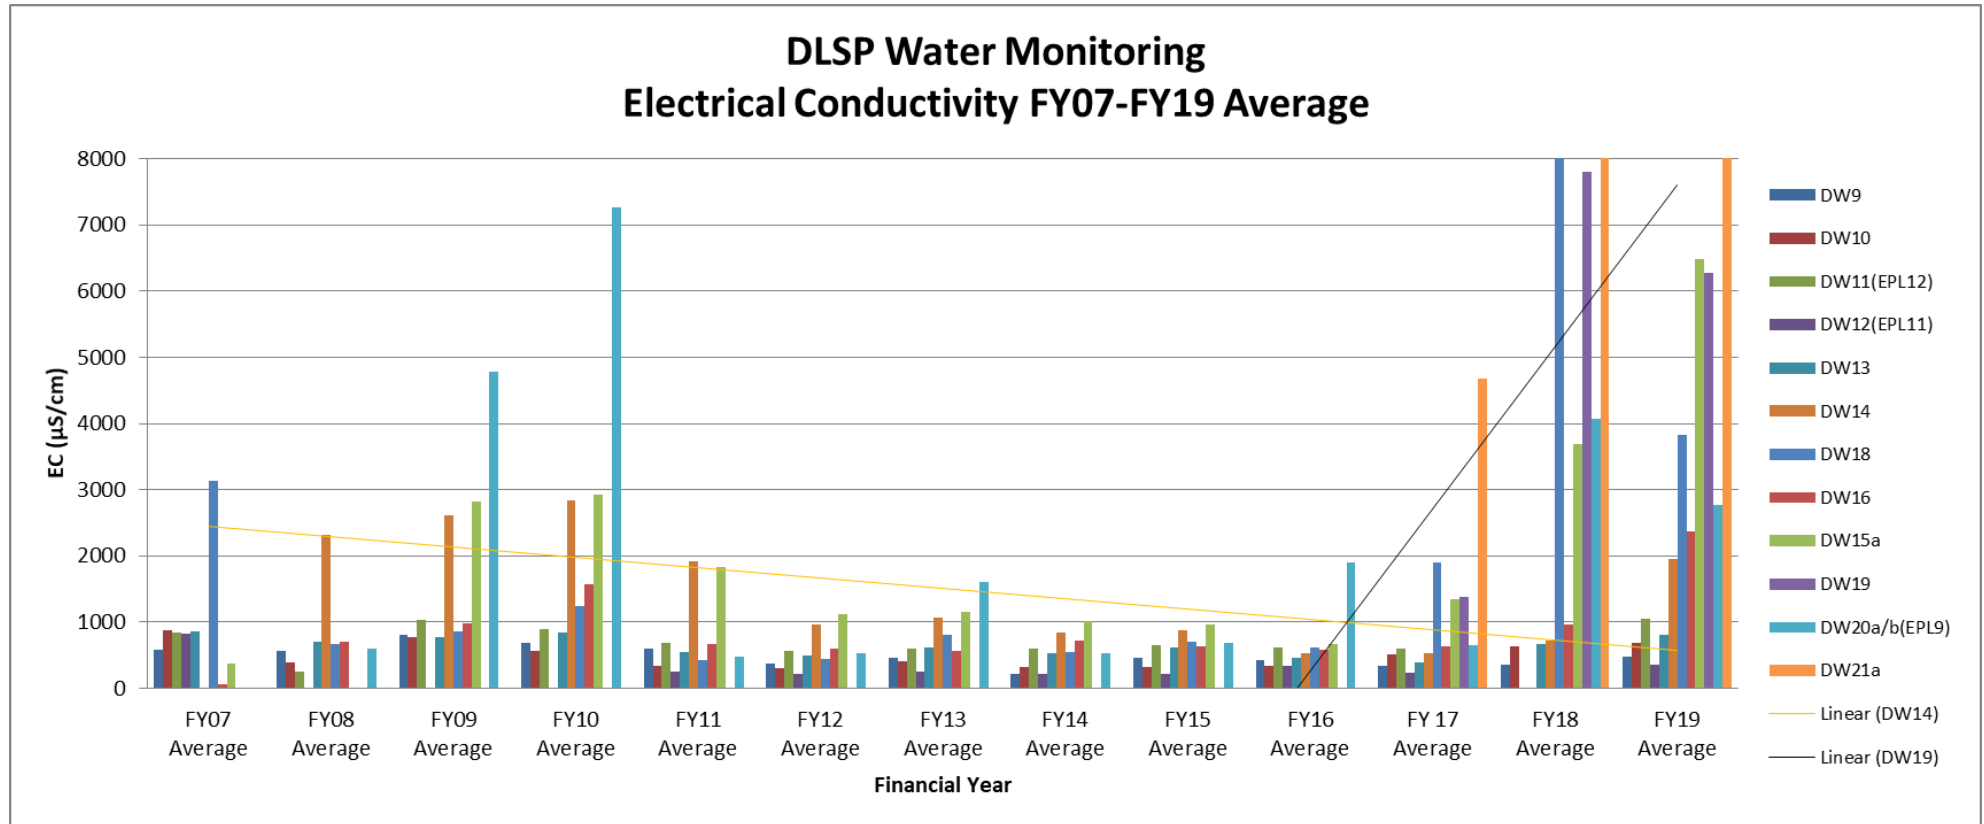
Figure 35 DLSP Conductivity Historical Trends

- Salinity is generally higher in the southern sections of Stage 3 in close proximity to the tidal zone at Rocklow Creek. This is a predicted outcome from the EIS based on the natural conditions of the site and is discussed below.

Initial investigations from the original DLSP EIS commissioned by R.W Corkery described that the groundwater within the southern section of Stage 3 contains slightly brackish water (TDS >2,500) which corresponds to a salinity far greater than the 1,500 μ S/cm threshold within the WQO detailed in S3.C24. As the dredging progresses south in Stage 3 near Rocklow Creek, the infiltration of this tidal brackish water into the Stage 3 dredge pond will be unavoidable and completely expected based on the natural conditions present in Stage 3.

Monitoring will continue for all parameters in the next reporting period. Backfilling will commence within the southern and eastern section of Stage 3. It is expected once backfilling and landform construction commences in the southern section of Stage 3, salinity caused by tidal saline flow will decrease in the stage 3 pond.
