**Berrima Colliery
Performance Monitoring Program
Scientific Report
Environment Protection Licence 608**

28 February 2020

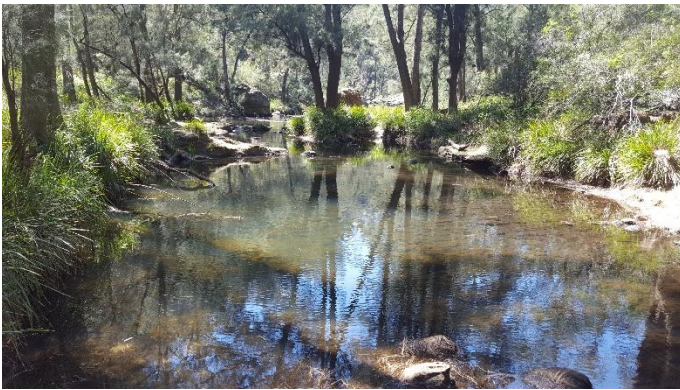
Plate 1a WR1km dn in 2019

-
-
- ❑ Site 1: Mine Adit - Naturally occurring groundwater is captured in the underground workings and is discharged into the Wingecarribee River. The monitoring point is referred to as the V Notch Weir (EPL Point 4).
 - ❑ Site 3: WR 300 DN - This site is located in the Wingecarribee River approximately 300m downstream of the confluence with the mine discharge water.
 - ❑ Site 4: WR 1km DN - This site is located in the Wingecarribee River approximately 1km downstream of the confluence with the mine discharge water.
 - ❑ Site 5: WR 2km DN - This site is located in the Wingecarribee River approximately 2km downstream of the confluence with the mine discharge water.
 - ❑ Site 7: WR 3km DN - This site is located in the Wingecarribee River approximately 3km downstream of the confluence with the mine discharge water.

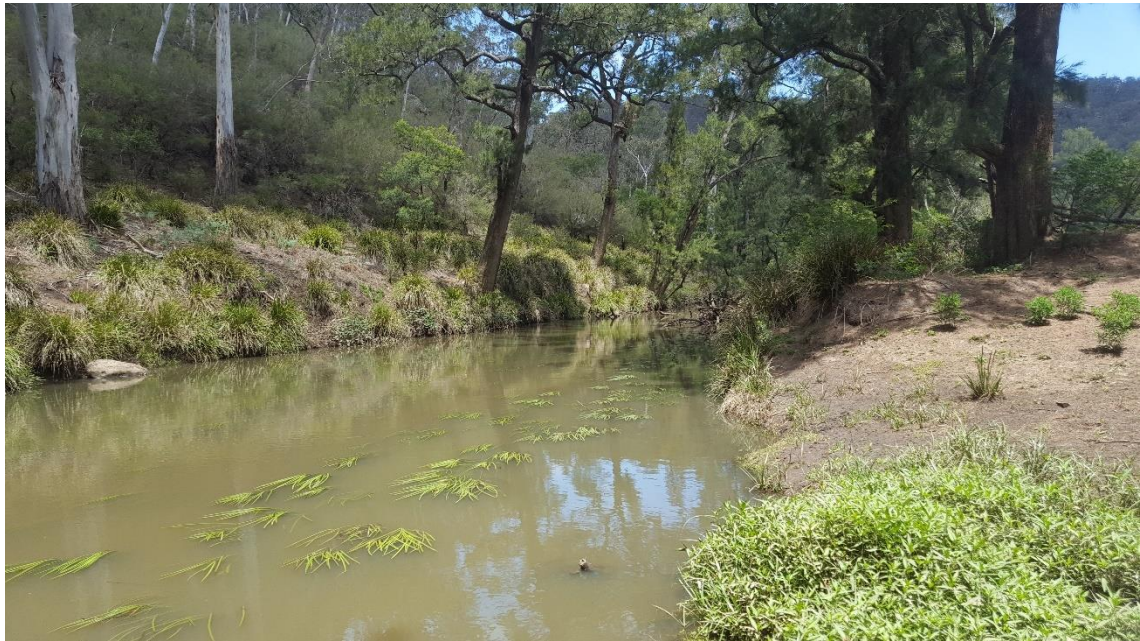
Plate 2 Biloela Sampling Site (2019)

This site is located in the Wingecarribee River at Biloela Camp Site approximately 6km downstream of the confluence with the mine discharge water. It is referred to as Site 8: Biloela. Plate 2 shows the site in 2019.

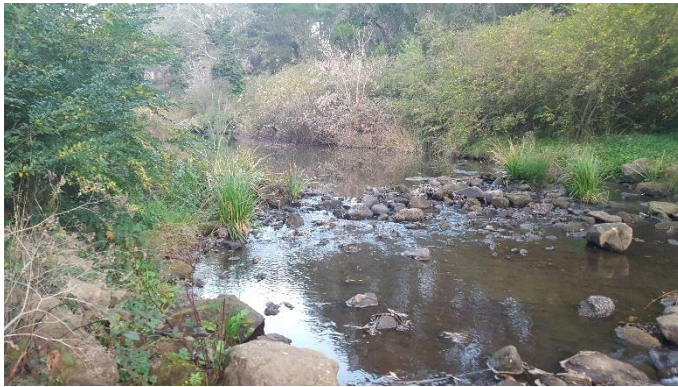
Plate 3a Upstream Site 2019

- Upstream - Wingecarribee River upstream of the mine adit discharge at Old Hume Highway Crossing at Berrima (Licence Point 9).
- Macarthur's Crossing - Wingecarribee River upstream of the mine adit discharge at Macarthur's Crossing (Licence Point 10).
- Biloela - Wingecarribee River downstream of the mine adit discharge at Biloela Camp Site (Licence Point 11).
- Downstream - Wingecarribee River downstream of mine adit discharge at Black Bob's confluence (Licence Point 12).

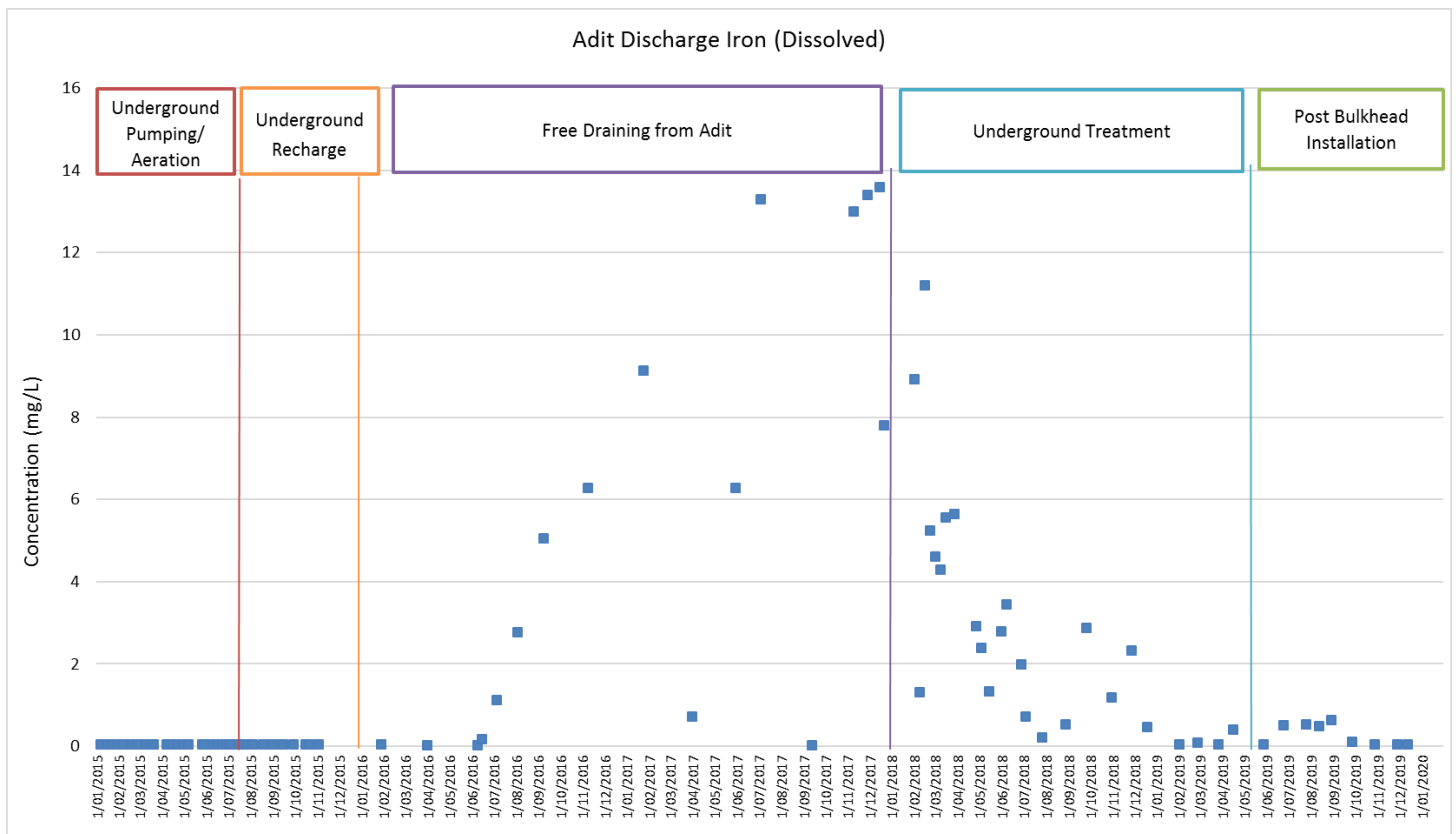
Graph 3.3 - Adit Discharge Iron Concentration

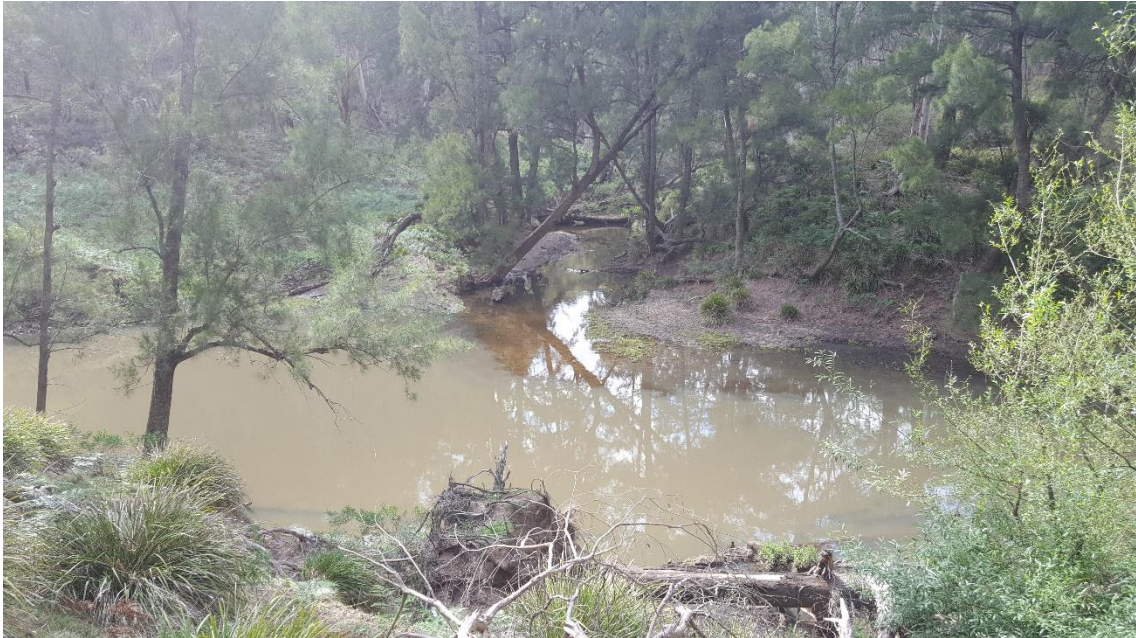
Plate 5 shows the Wingecarribee River taken at the confluence of the Medway Rivulet. The photo was taken in December 2018 at a time when the mine had temporarily stopped discharging but followed a storm event. The photo shows the visible difference in the quality of water from Medway Rivulet (relatively undisturbed catchment) compared with sediment load within the Wingecarribee River. It is this contrasting water quality that occurs during rainfall events that complicates the assessment of water quality impacts from the mine discharge. Conversely, there are periods of extremely dry conditions when the Wingecarribee River essentially stops flowing. During these periods, the mine discharge can make up a large percentage of the river flow.

Plate 5 Wingecarribee River at the Confluence of the Medway Rivulet December 2018

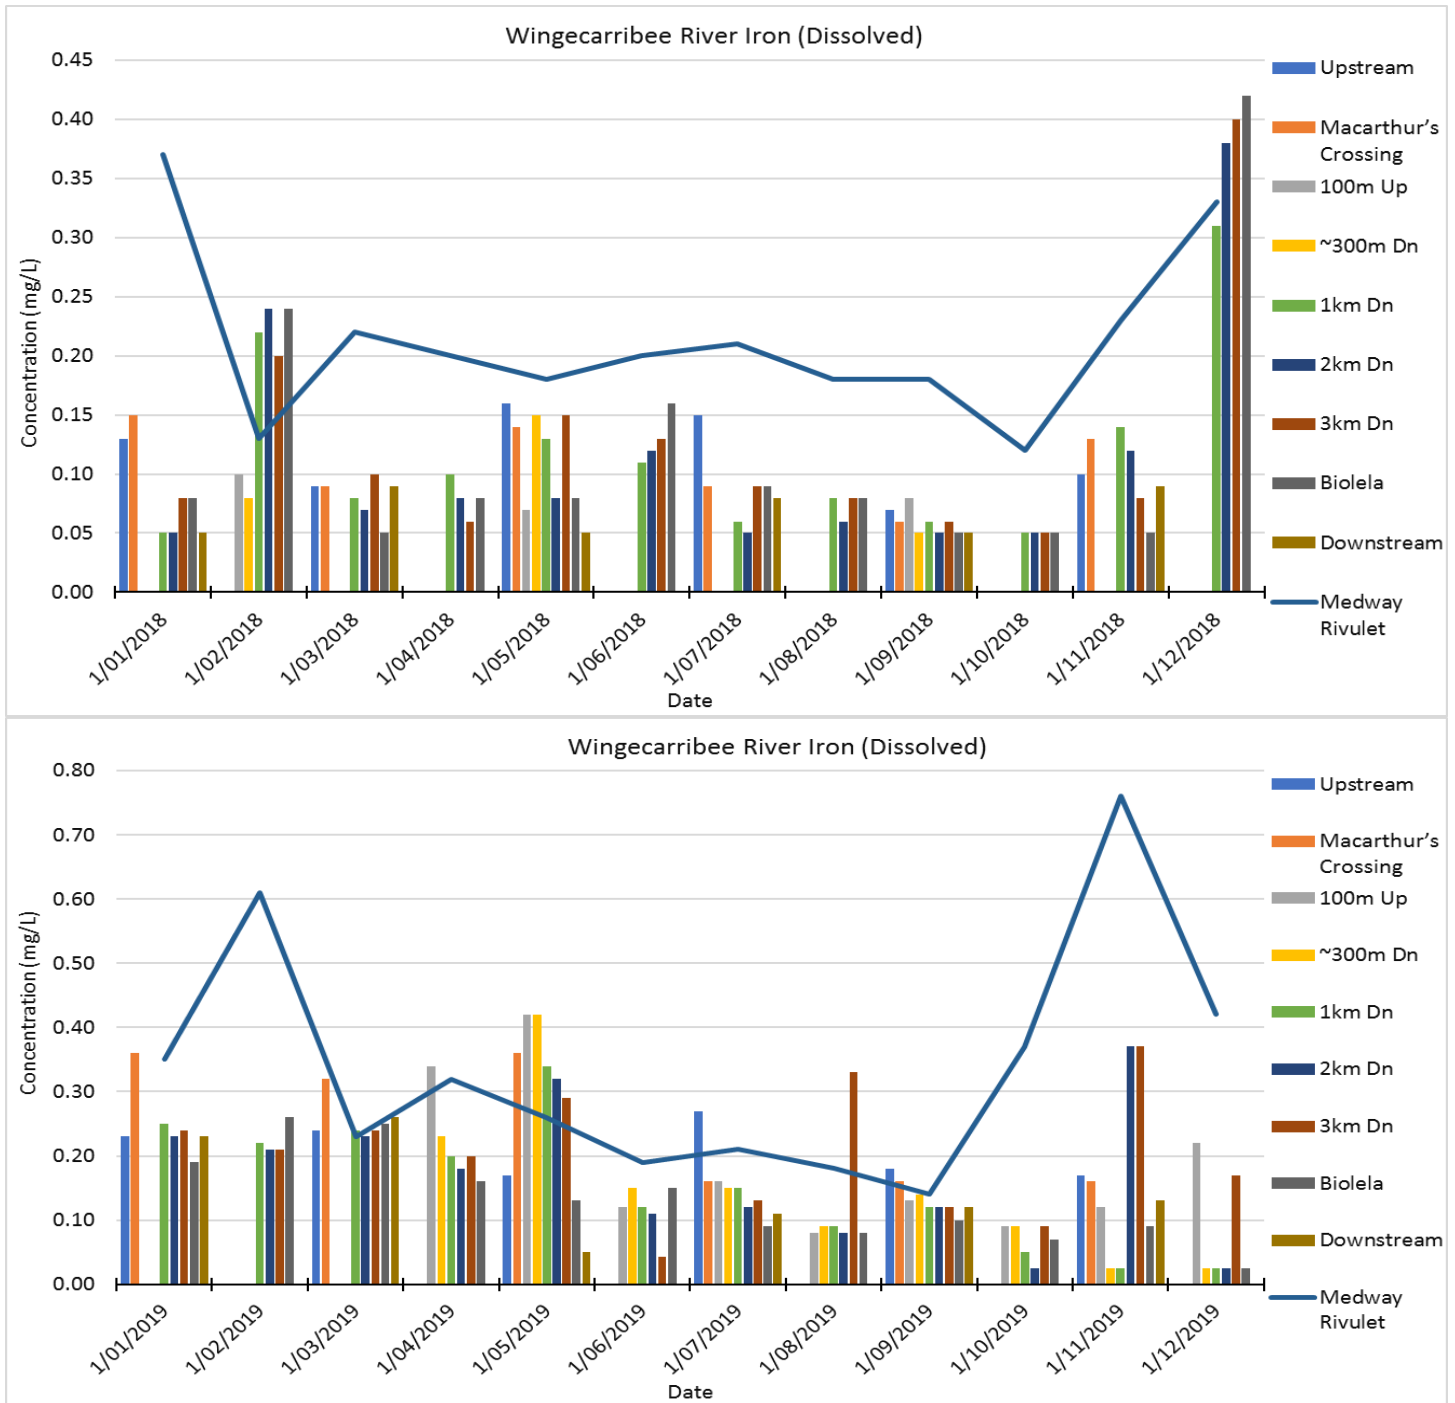
As seen on Graphs 3.7, the Iron concentration recorded in the Medway Rivulet is often higher than that recorded in the Wingecarribee River, with an average over 2018 and 2019 of 0.27 mg/L.

Graph 3.7 – Wingecarribee River Iron Concentration

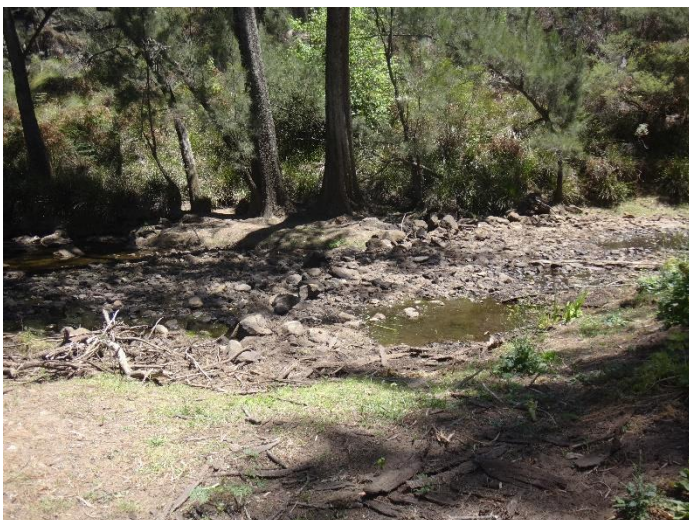
Plate 6a Macarthur's Crossing November 2019

Although the Wingecarribee River flow data is no longer available at Macarthur's Crossing, a photographic record has been used to discern differences in flow between months as seen in Plate 6a and Plate 6b below.

The Wingecarribee River is a highly regulated system with three water supply structures and many farm dams which starve the river of natural water flow. As a result, the river upstream of the mine suffers from long periods of little to no flow, sometimes despite rainfall occurring during these periods. This trend is observed to be worse over the past few years, with a lower average and fewer flushing events.

The consequence of low flow conditions is that the discharge from Berrima Colliery becomes the dominant water source for the river. Mixing becomes non-existent in very low flow conditions and other natural groundwater baseflow contributions can influence overall water quality.

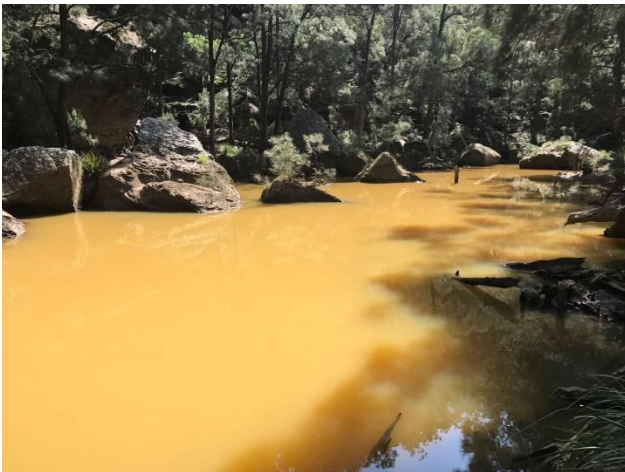
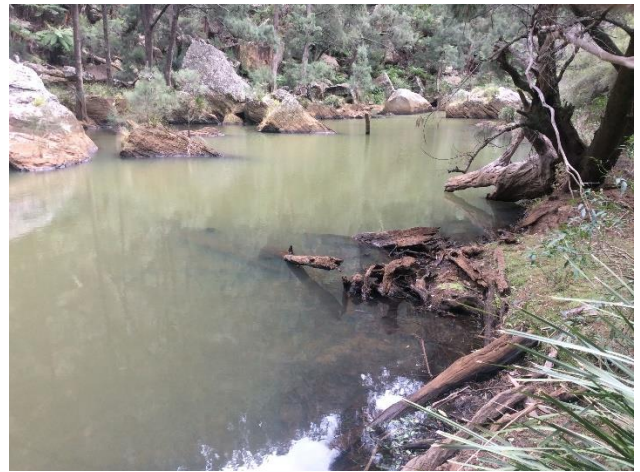
The first period of free draining involved the discharge of significantly poorer quality water which caused a deterioration in water quality in the Wingecarribee River, particularly in the mixing zone downstream of the discharge point. The underground treatment system returned the water quality to similar levels that occurred during normal operations. This can be more readily seen visually as shown in Plates 7a and 7b.

Plate 7a – Mixing Zone before underground treatment

Plate: 7b: Mixing Zone after underground treatment

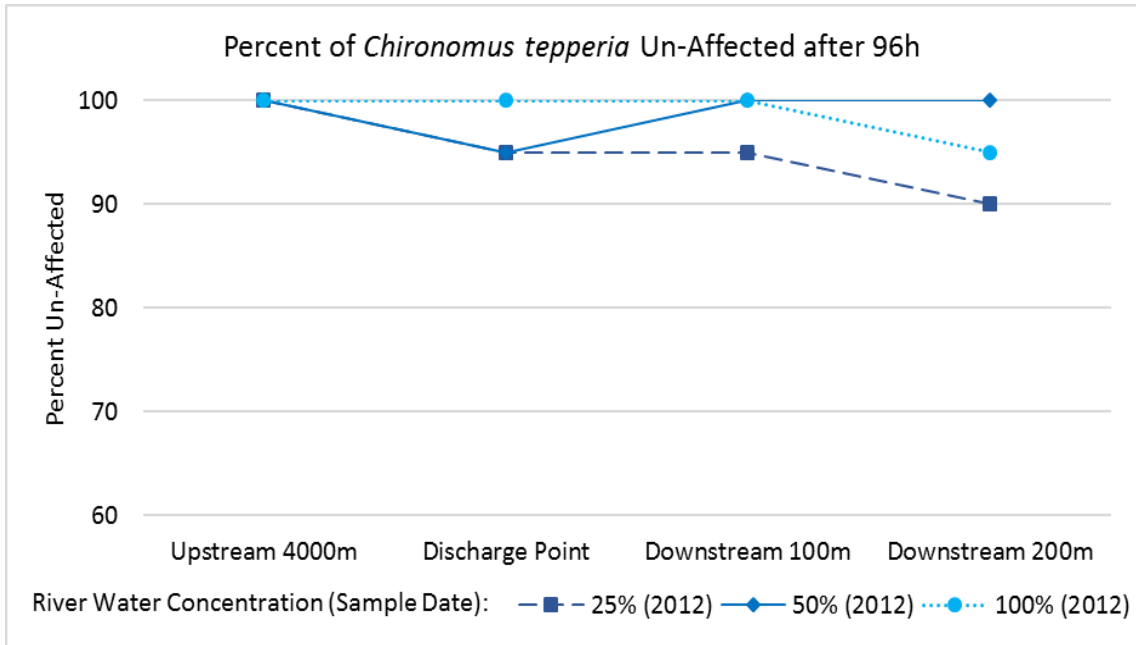
The non-biting midge (chironomid) larvae was used as an indicator in 2012 only. Percentages of unaffected individuals remained above or at 90% at all dilutions and sampling sites. Results in Graph 5.3 indicate that there was little acute toxicity apparent for this species following 96 hours of exposure.

Graph 5.3 Percent *Chironomus tepperia* unaffected after 96h

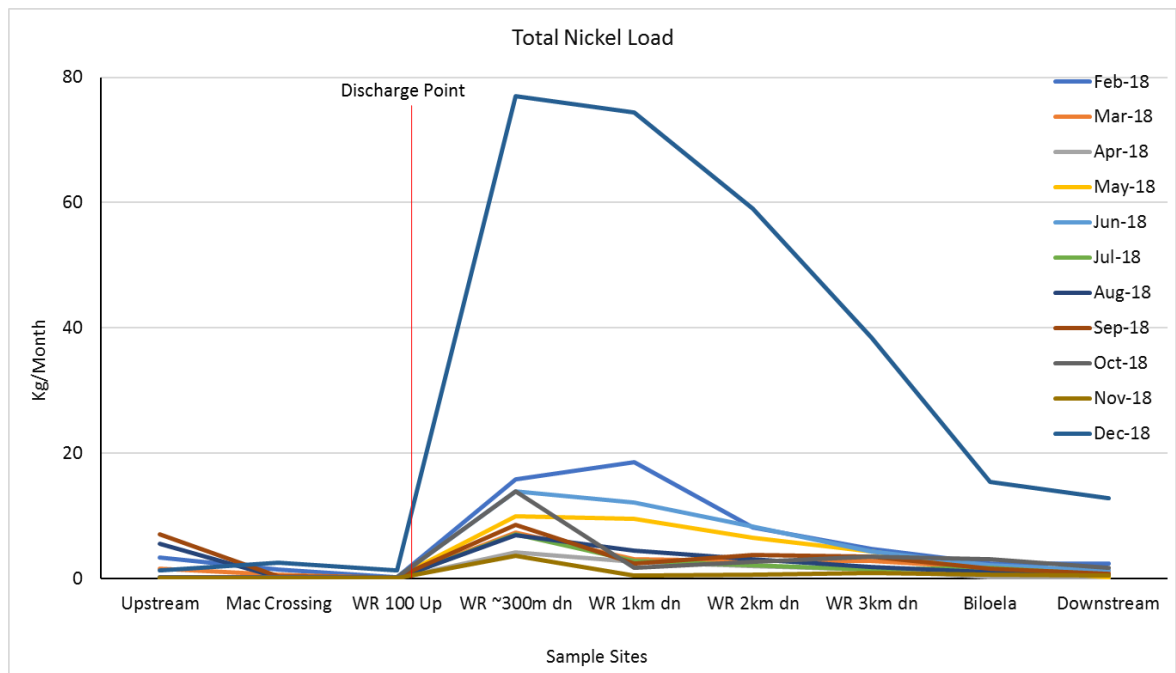
Graph 6.18 Total Nickel Load in the Wingecarribee River During 2018
